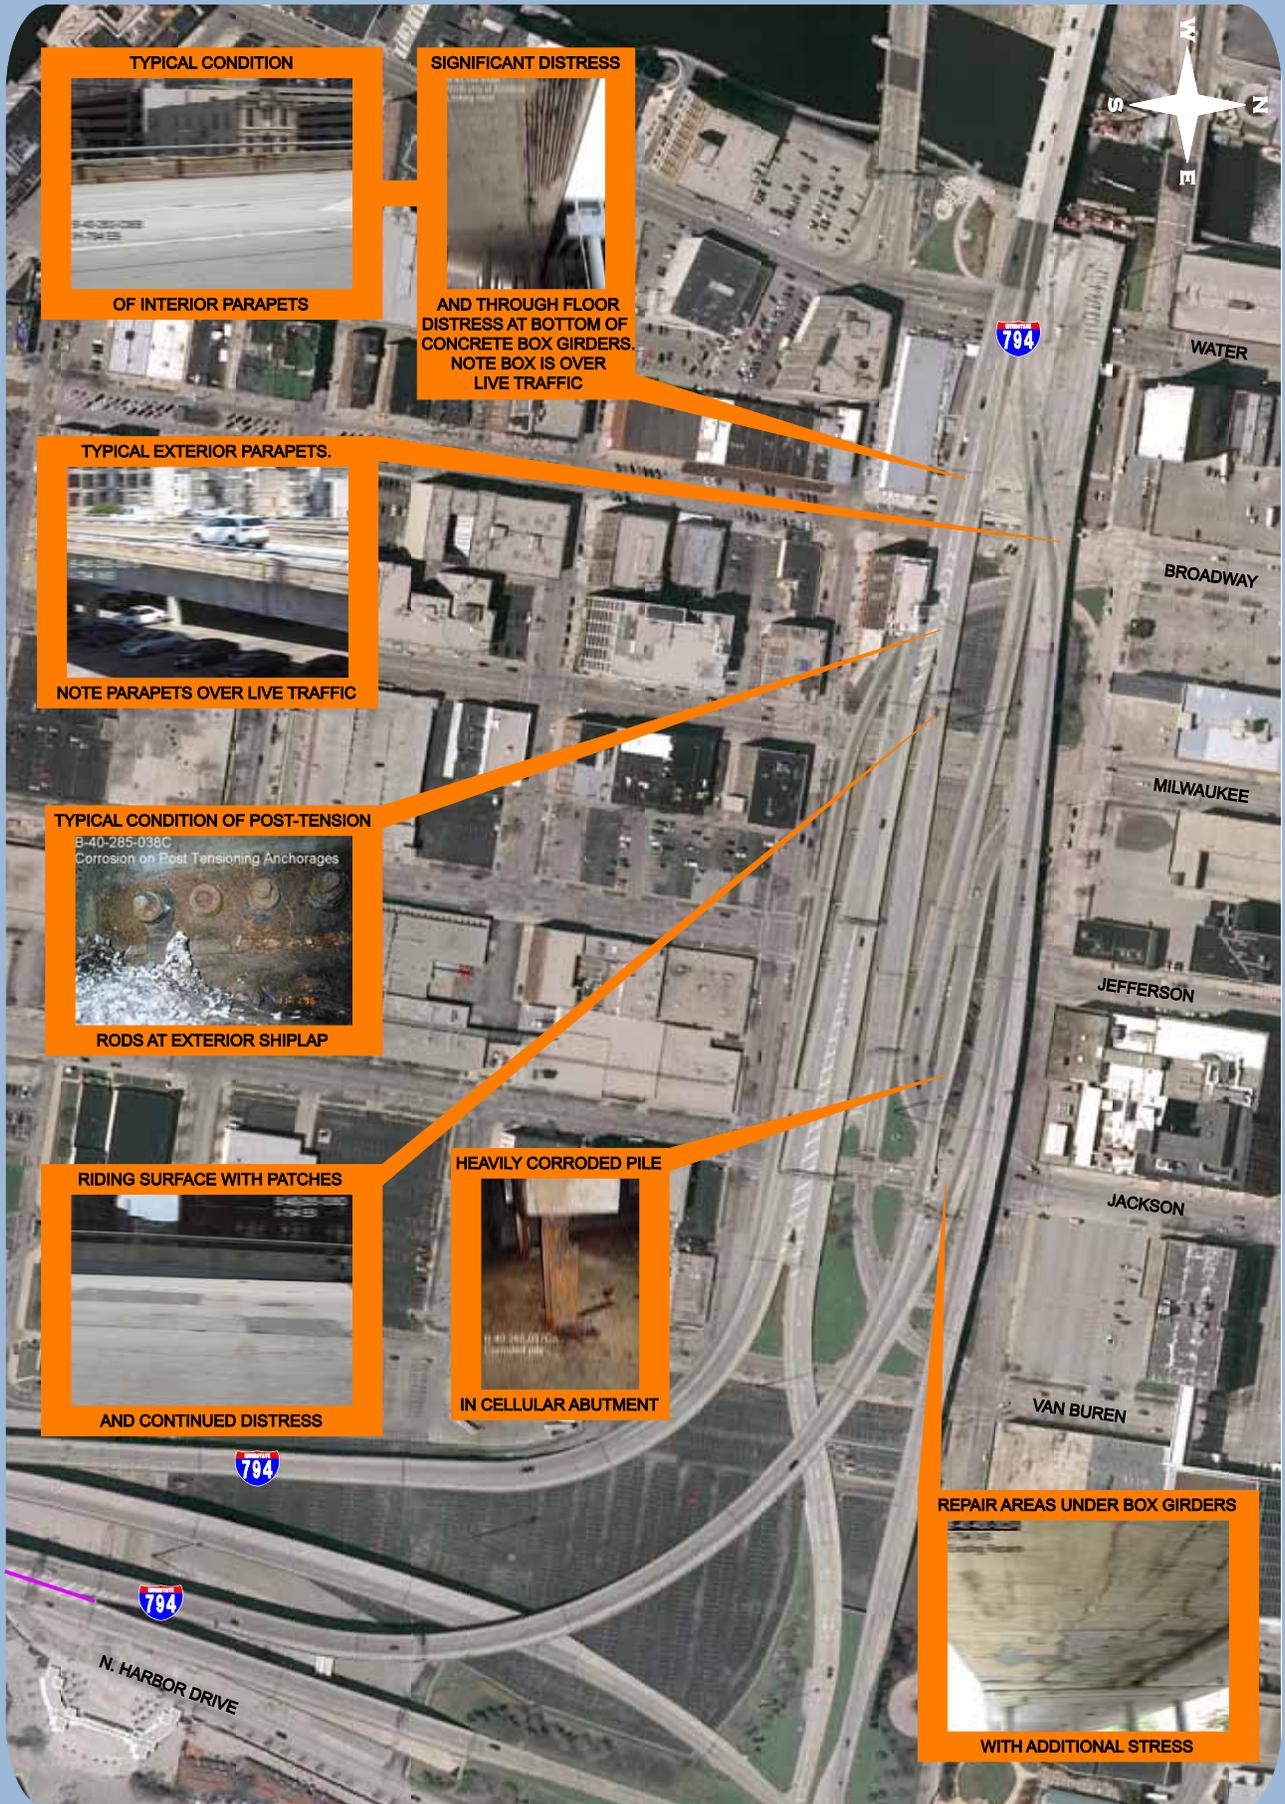
TYPICAL CONDITION
OF INTERIOR PARAPETS

SIGNIFICANT DISTRESS
AND THROUGH FLOOR
DISTRESS AT BOTTOM OF
CONCRETE BOX GIRDERS.
NOTE BOX IS OVER
LIVE TRAFFIC

TYPICAL EXTERIOR PARAPETS.
NOTE PARAPETS OVER LIVE TRAFFIC

TYPICAL CONDITION OF POST-TENSION
B-40-285-038C
Corrosion on Post Tensioning Anchorages

RIDING SURFACE WITH PATCHES
AND CONTINUED DISTRESS

HEAVILY CORRODED PILE
IN CELLULAR ABUTMENT

REPAIR AREAS UNDER BOX GIRDERS
WITH ADDITIONAL STRESS
